Restoring New Haven's East Rock Road Bridge

By Thomas Strnad, P.E.

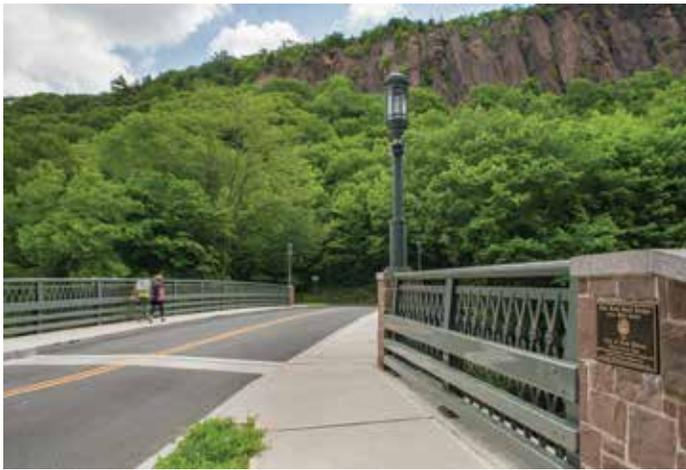
The rehabilitation replicated the ornamental pedestrian rail system and added decorative lighting.

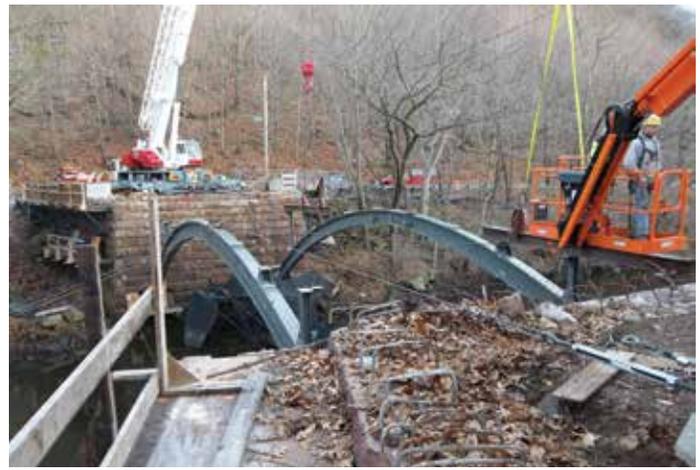
Construction views showing erection of rehabilitated steel arches.

The strengthened bridge elements were then transported from Boston back to the site, where they were erected in their original location. The bridge construction was completed with the installation of new floor beams and a steel grid deck partially filled with concrete, which was selected to reduce loads on the arch while at the same time providing a paved riding surface.

- The existing arches were riveted I-section members consisting of a web plate, flange angles and cover plates, with lower steel material properties resulting in insufficient capacity to meet current standards for legal loads. When the bridge was disassembled, the arch pieces were sent to Boston Bridge and Steel, where the contractor removed the rivets and cover plates and installed thicker cover plates on the top and bottom flanges to increase their capacity. The contractor blast cleaned all of the pieces, removed lead paint, repaired deteriorated steel, and painted each piece. The shop fabricated the new floor beams to support the bridge deck and shipped the pieces back to New Haven for reinstallation. All of the original arch pins were replaced as part of the reconstruction. Because the arch strengthening resulted in a deeper section, ROTH A Contracting Company took
